# **EMERGENCY ACTION PLAN FOR MADSEN CREEK FLOW AND WATER QUALITY CONTROL POND**

**State ID KI08-1862  
King County Regional Storm Facility DR0642**

Prepared by:  
KING COUNTY  
DEPARTMENT OF NATURAL RESOURCES  
WATER AND LAND RESOURCES DIVISION  
STORMWATER SERVICES SECTION

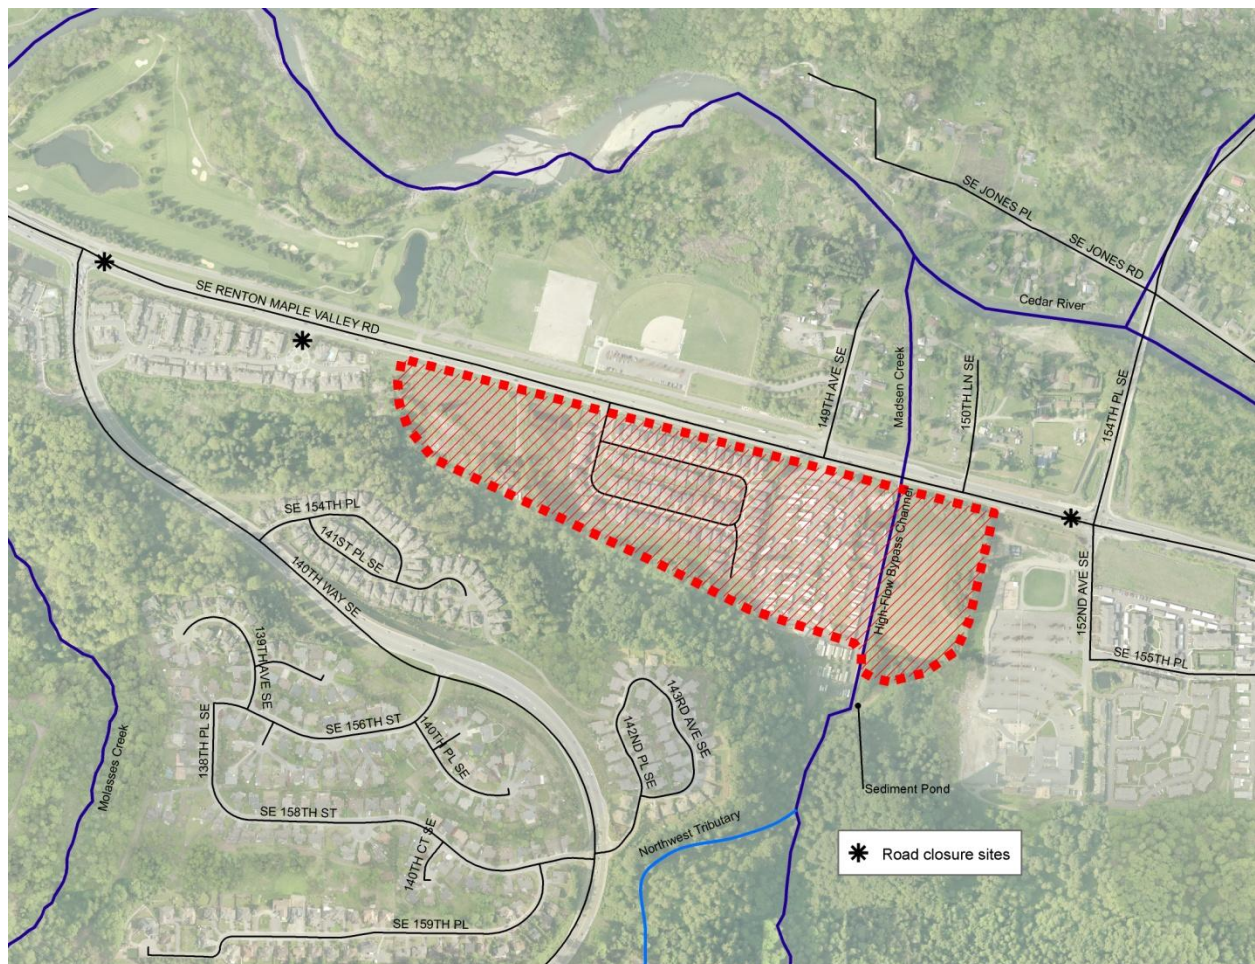
### ROAD CLOSURE MAP

The following public roads should be closed if a **FAILURE IN PROGRESS** or a **FAILURE IMMINENT** condition exists. Although inundation of State Route 169 is extremely unlikely to occur, road failures may still be possible within the conveyance system beneath the road. Water is eventually discharged to the Lower Cedar River. Until road is deemed safe by a transportation engineer, close State Route 169 between 140<sup>th</sup> Way SE and 152 Ave. SE; close the driveway entrance just east of 140<sup>th</sup> due to the potential of through traffic.
